Inspection Report & Repair Estimate

Sub-Zero 532 built-in refrigerator/freezer • Inspected on site October 27, 2026

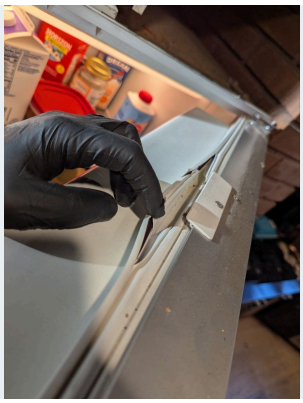
Condenser contaminated with dust and debris

The mechanical compartment has significant accumulated dust and debris. The condenser releases the heat removed from the food compartments, and buildup restricts that heat transfer. Our technician performed a limited cleaning during the inspection; a full condenser cleaning and vacuuming is still required.

Debris buildup. Close view of accumulated dust and debris in the compartment.

Condenser compartment. Upper mechanical compartment with dust and debris on the components and surrounding surfaces.

Debris near tubing. Dust and debris near the tubing on the condenser side of the compartment.

Gasket pulled from track. Gasket section pulled away from its mounting track along the upper door edge.

+ Complete condenser cleaning and vacuuming

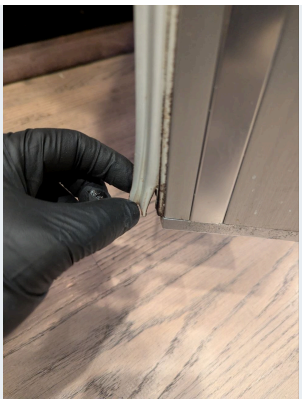
The refrigerator and freezer door gaskets show tearing, deformation and sections separating from the door. A damaged gasket cannot seal the door properly. Our technician recommends replacing both gaskets as corrective work.

Gasket separation. Door gasket separating along a vertical edge.

+ Replacement of both refrigerator and freezer door gaskets

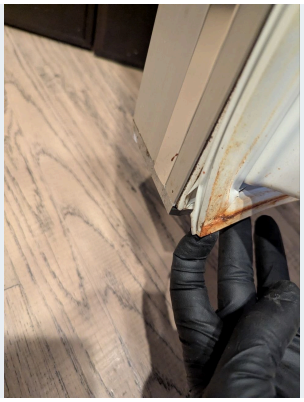
Gasket tears. Tears and deformation along the upper gasket edge.

Lower corner. Lower gasket corner with discoloration on the adjacent metal edge.
